Transmission Facility Outages During the Northeast Snowstorm of October 29–30, 2011

Causes and Recommendations

Federal Energy Regulatory Commission *and* the North American Electric Reliability Corporation

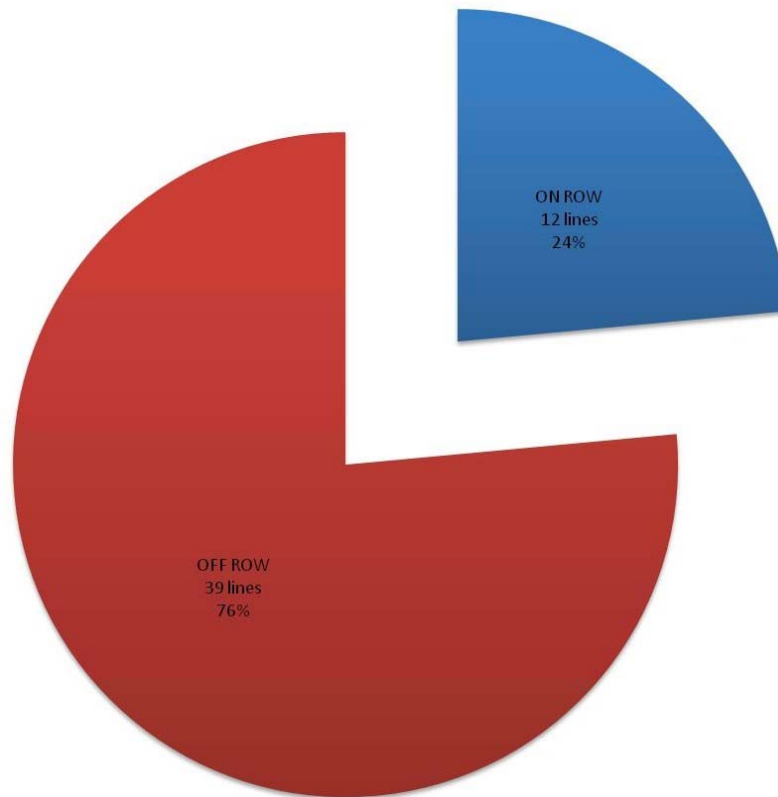
Figure 12: Fallen Trees Located on Rights-of-Way and Off-Rights-of-Way

The vast majority of transmission line outages — fifty-five out of seventy-four, or nearly 80% — were caused when snow-weighted leafy trees contacted transmission lines.⁶² All but two of these trees were healthy. Twenty-five percent of these trees were located within the utility’s right-of-way, and therefore, were likely within the utilities’ rights to maintain.

Specifically, thirty-nine transmission line outages resulted from off-right-of-way trees falling onto transmission lines, resulting in loss of power to approximately 84,000 customers. An additional twelve transmission line outages, resulting in 13,000 customer outages, occurred when trees located *inside* a utility’s full right-of-way⁶³ fell into transmission lines. The only tree-caused 345 kV line outage occurred when a sixty-five-foot tall tree located within a full right-of-way (forty-six feet from the nearest transmission line) fell. All of the trees that fell into lines from within the utility’s full right-of-way were located outside the area in which the utility performs vegetation management (known as the “maintained right-of-way”).⁶⁴
